FALCON & COMMODORE TROUBLESHOOTING

In this, the first part of a two-part Techstop series, we review some common problems, fitting hints and technical trivia relating to Falcons and Commodores. Most of these issues can also be applied to other makes and models.

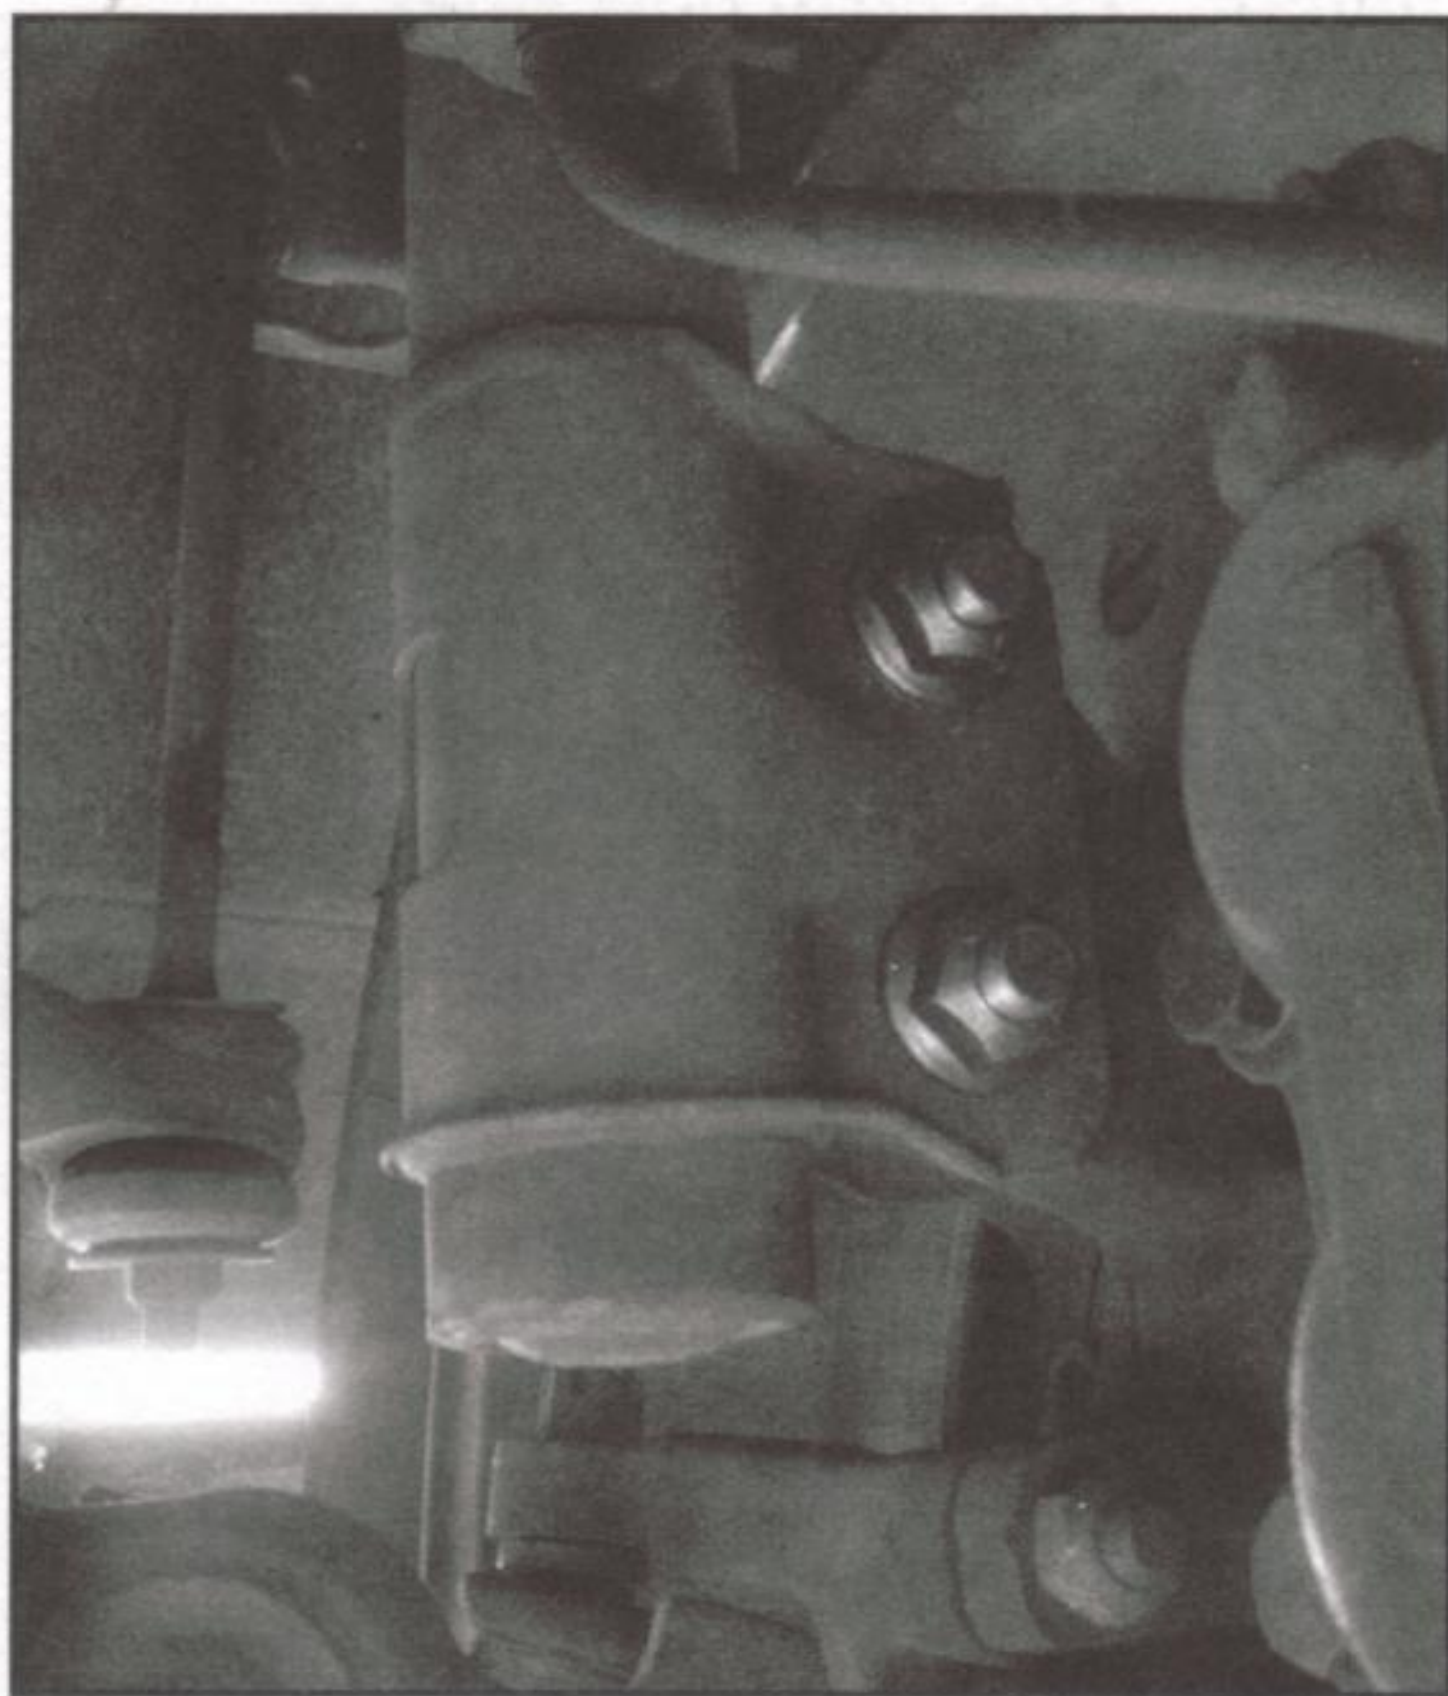
On VR - VT Commodores, the most common bolt in the suspension to be undone is the strut's clevis bolt that is a TTY. These bolts must be replaced whenever they are removed or loosened.

Above: The Clevis bolts or TTY bolts on a VR Commodore

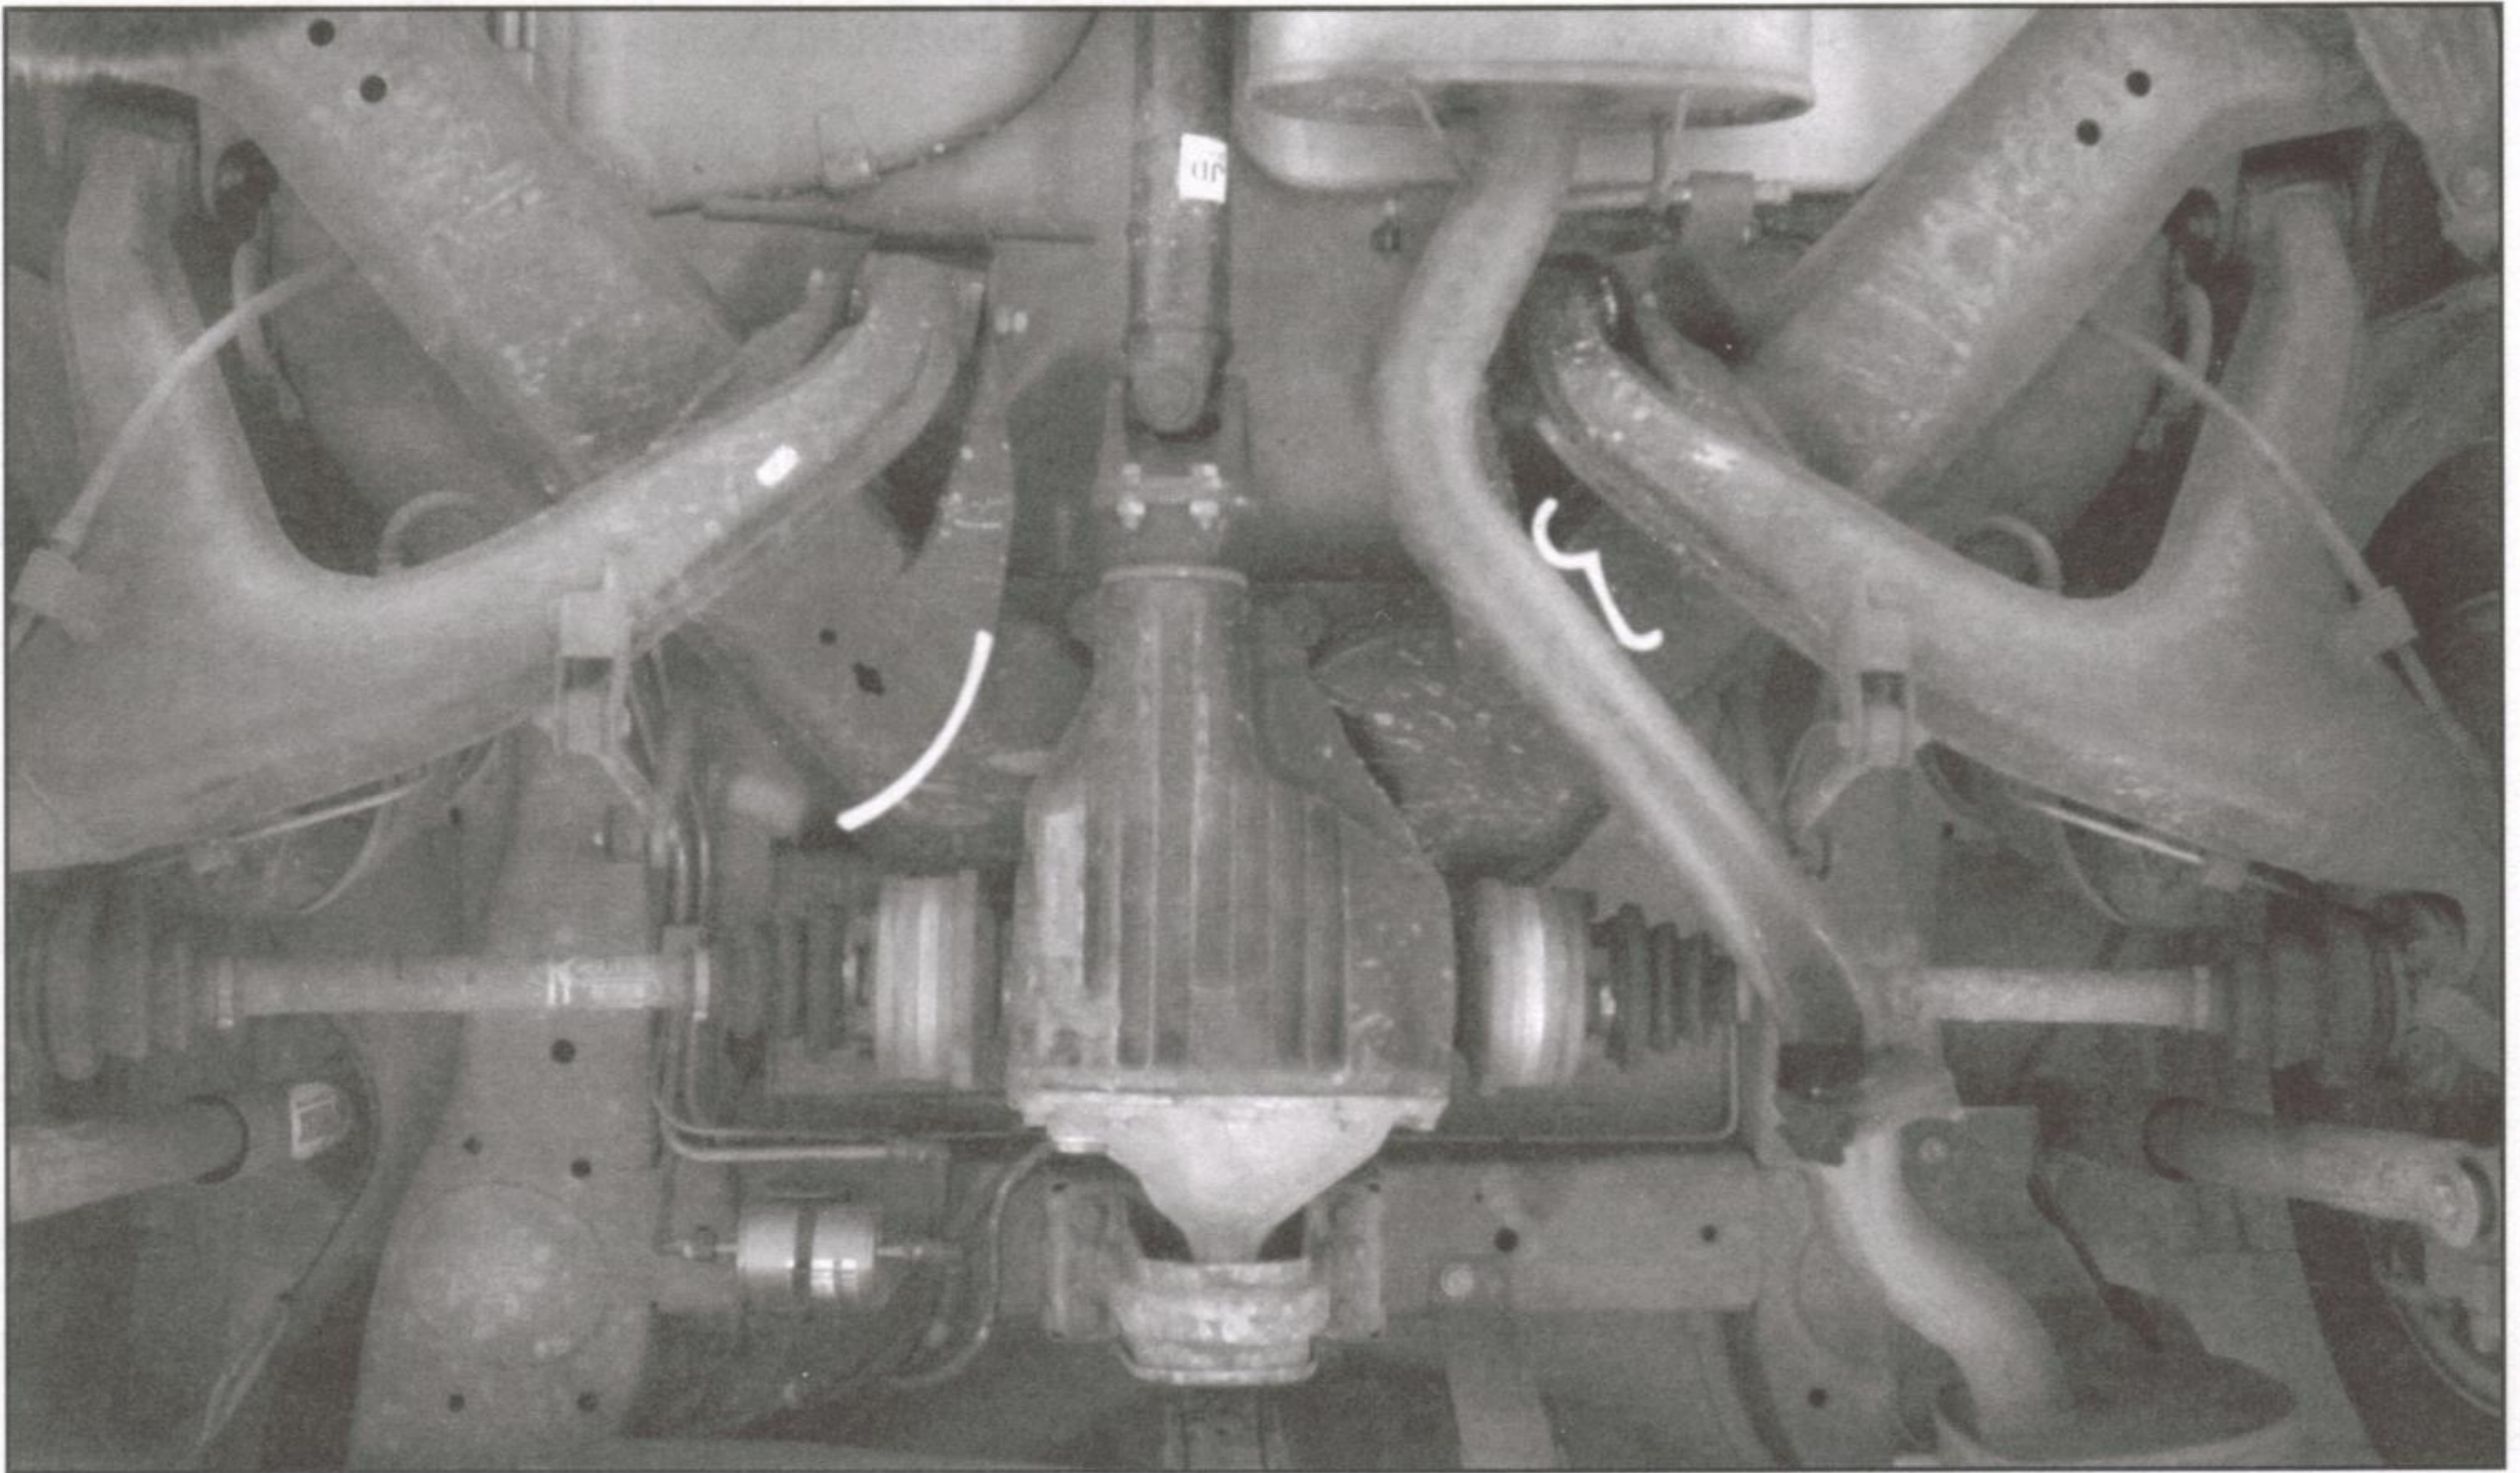
There have been isolated instances of the IRS cross member cracking and eventually breaking on VR & VS models. The failure occurs on the structural cross member between the trailing arm's inner pivot mounting and the differential carrier mounting bolts.

- A click or creaking noise as the vehicle accelerates or brakes
- Rear steer symptom similar to a broken rear leaf
- Severe thumping or banging
- Rear end steps out under acceleration
- Severely out of specification rear toe and camber
- Loss of drive

If the cross member breaks completely, the result can be that the axle is pulled out of the differential carrier.

This image shows the potential fatigue points of the IRS cross member in a VT Commodore.
